Walking Audit Final Report

City of Coconut Creek:

Lyons Road

February 2015

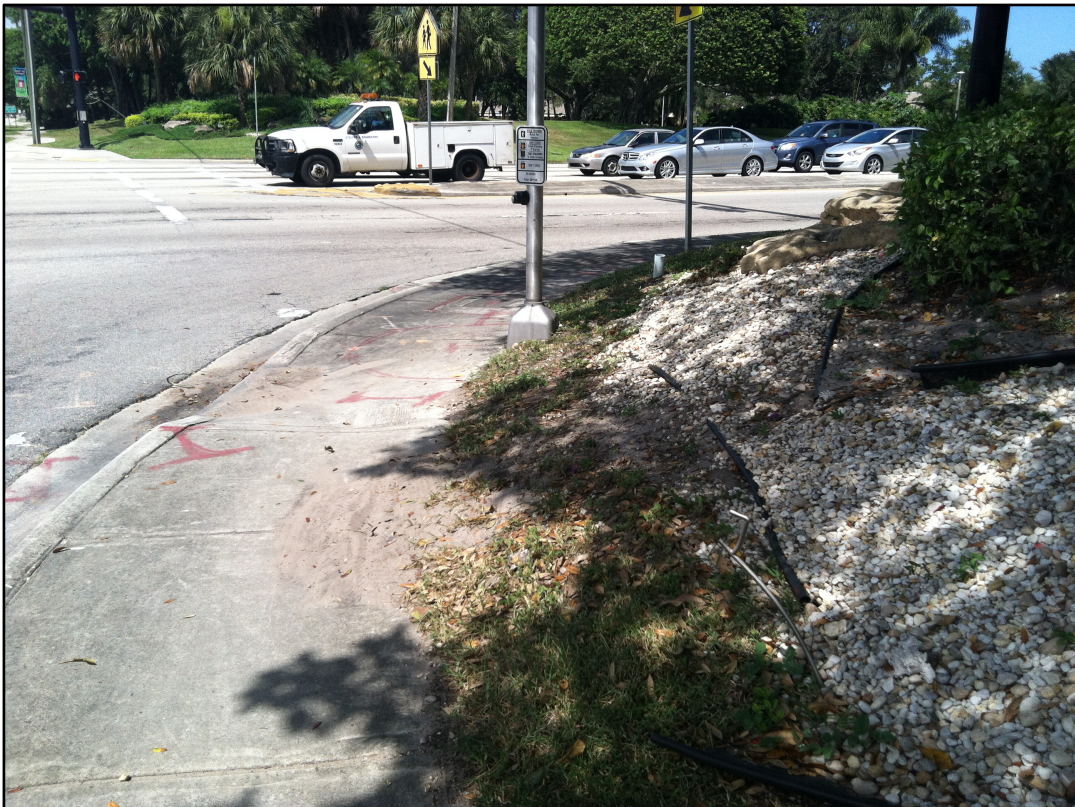
Figure 09: Example Finding – Relates to Recommendation T1

T1. Address sidewalk and roadway hazards such as debris, obstructions, and cracks

- a. Description: The pedestrian signage at this location is unclear. The allotted time to cross is insufficient for some older adults and the cars turning right on red pull into the crosswalk at a dangerous speed, not fully stopping before the crosswalk.
- b. Appendix ID: 8, 34, 43
- c. Broward Complete Streets Guidelines: See Chapters 7, 8, 11
